# Limited Lead-Based Paint Survey

Porter County Education Services  
Special Education Learning Facility  
750 Ransom Road  
Valparaiso, IN 46385

**Project Number:** 21.1387.3

**Date of Report:** August 16, 2021

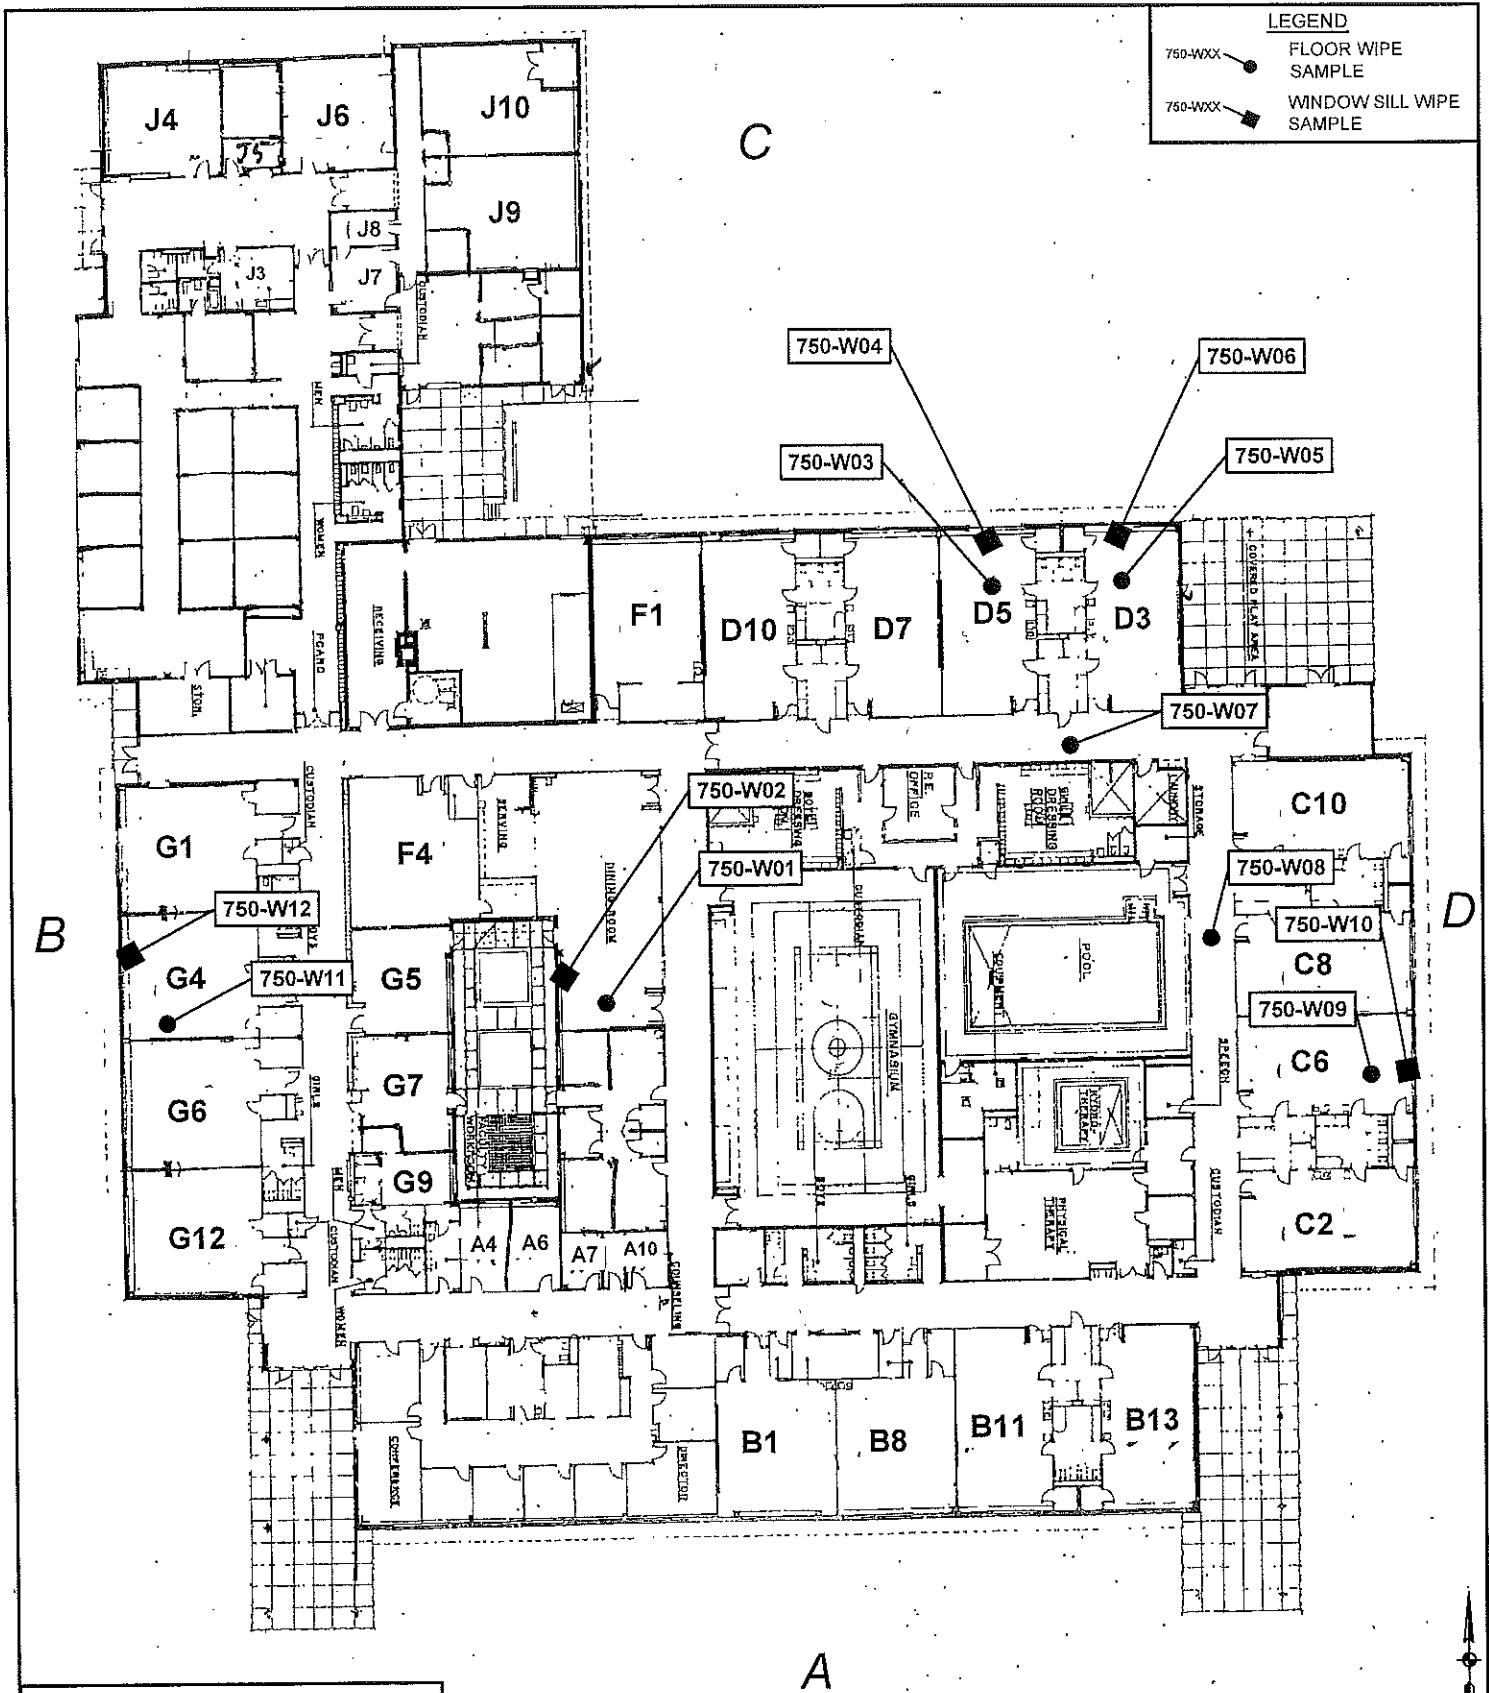
FIGURE

I am pleased to inform you that no lead dust hazards were detected during this assessment. In fact, no concentration of lead dust was identified in any of the samples collected above the level of detection. Please see the attached laboratory report and Floor Plans for all sample locations and results.

LEAD DUST WIPE SAMPLE LOCATIONS  
 LIMITED LEAD-BASED PAINT SURVEY  
 PORTER COUNTY SELF  
 750 RANSOM ROAD  
 VALPARAISO INDIANA

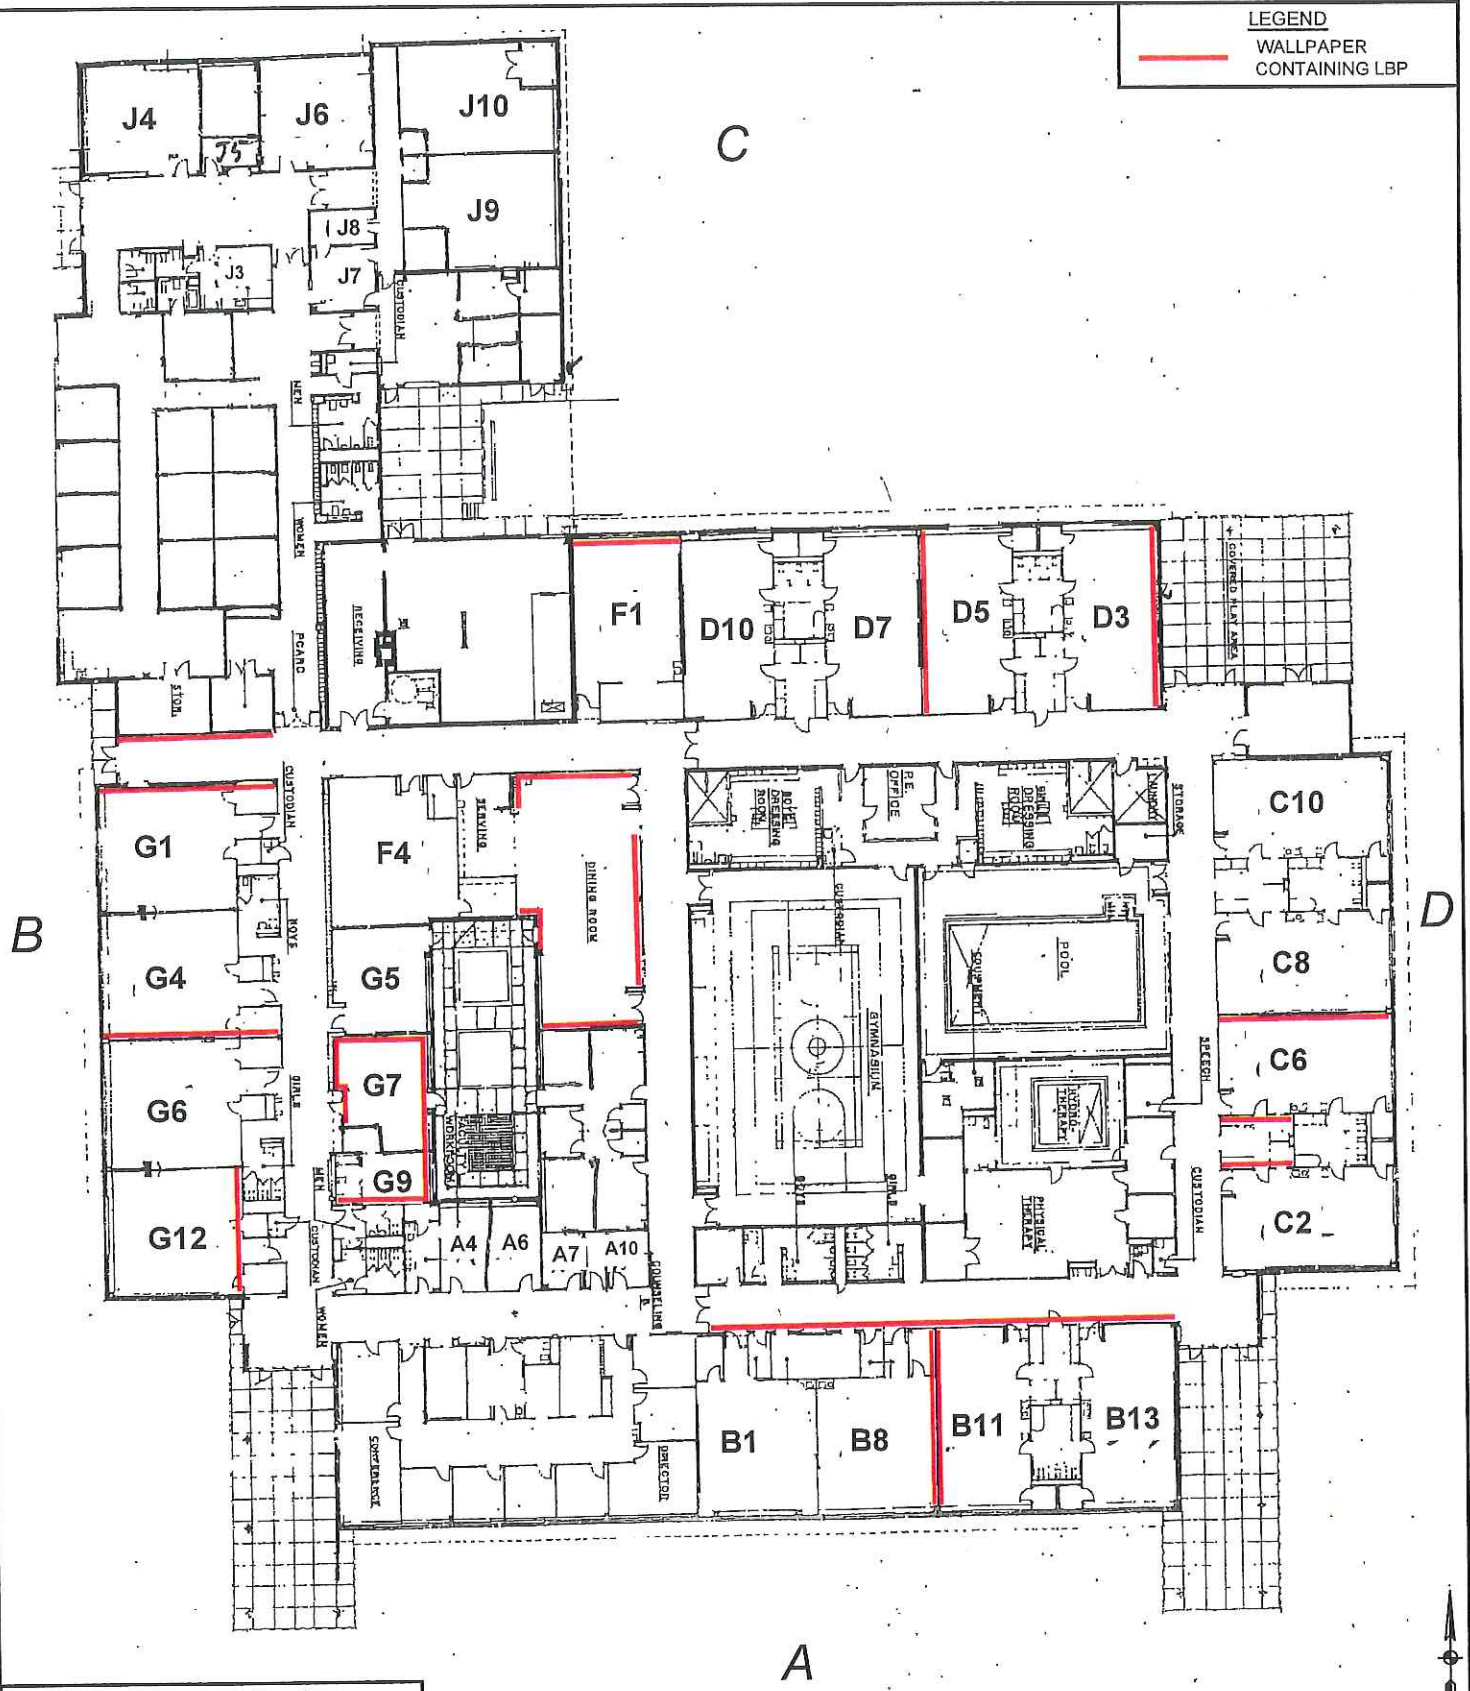
SHEET 2 OF 2  
FIGURE  
**2**

Please be advised that LBP was identified on the walls with painted wallpaper of a specific texture at various locations within the building. Multiple wallpapers of varying textures were tested as part of this investigation and only one particular texture was positive for LBP. Please refer to the attached XRF results and site plan for known locations.

— WALLPAPER  
CONTAINING LBP

IDENTIFIED LEAD-BASED PAINT  
LIMITED LEAD-BASED PAINT SURVEY  
PORTER COUNTY SELF  
750 RANSOM ROAD  
VALPARAISO INDIANA

Therefore, it is my professional recommendation that all materials that have been identified to contain LBP within areas frequented by children aged 6 and younger be handled following the EPA Lead Renovation, Repair and Painting Rule (RRP) if they will be disturbed or become deteriorated. In addition, the OSHA Lead Standard for the Construction Industry, 29 CFR 1926.62 covers lead in a variety of forms, including paint with any detectable amounts of lead. During any renovation projects performed within the building, engineering and work practice controls should be implemented to reduce and maintain employee exposure to lead concentrations at or below the permissible exposure limit (PEL) of 50 µg/m<sup>3</sup> over an 8-hour work period. All workers performing work within the building shall have the appropriate EPA RRP and general OSHA training.

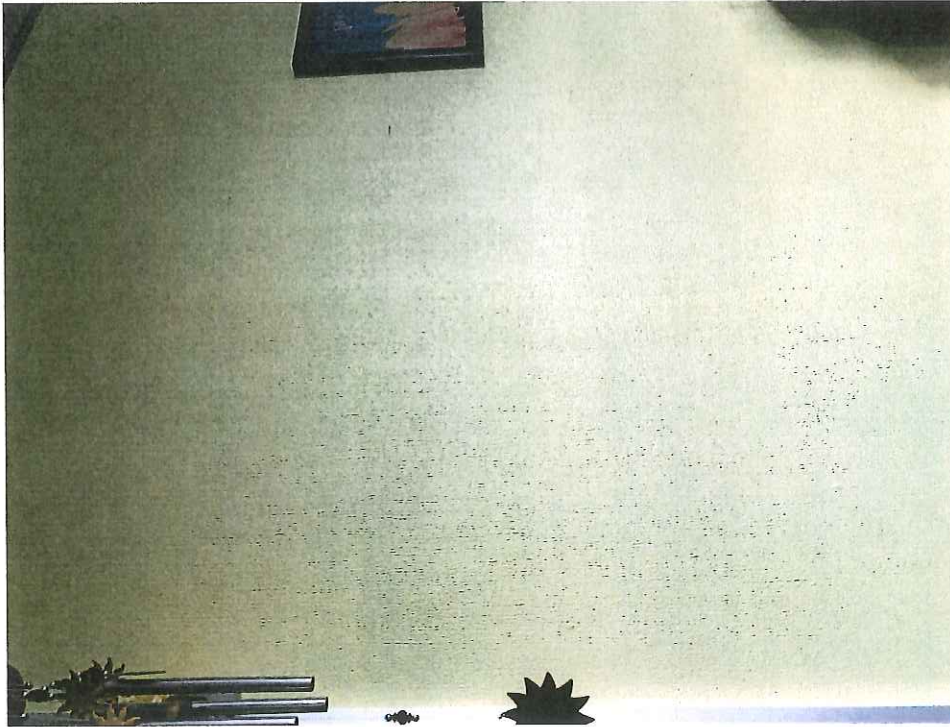
1. Wallpaper Containing Lead-Based Paint -- Room G4

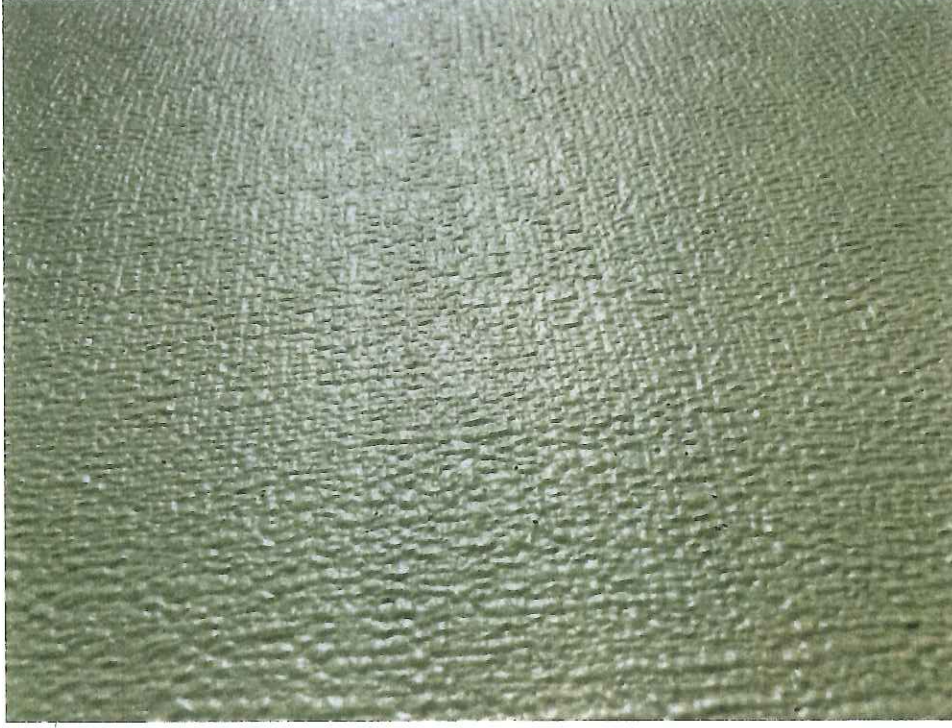
2. Closeup of Lead-Based Paint Wallpaper Texture --  
Room G4

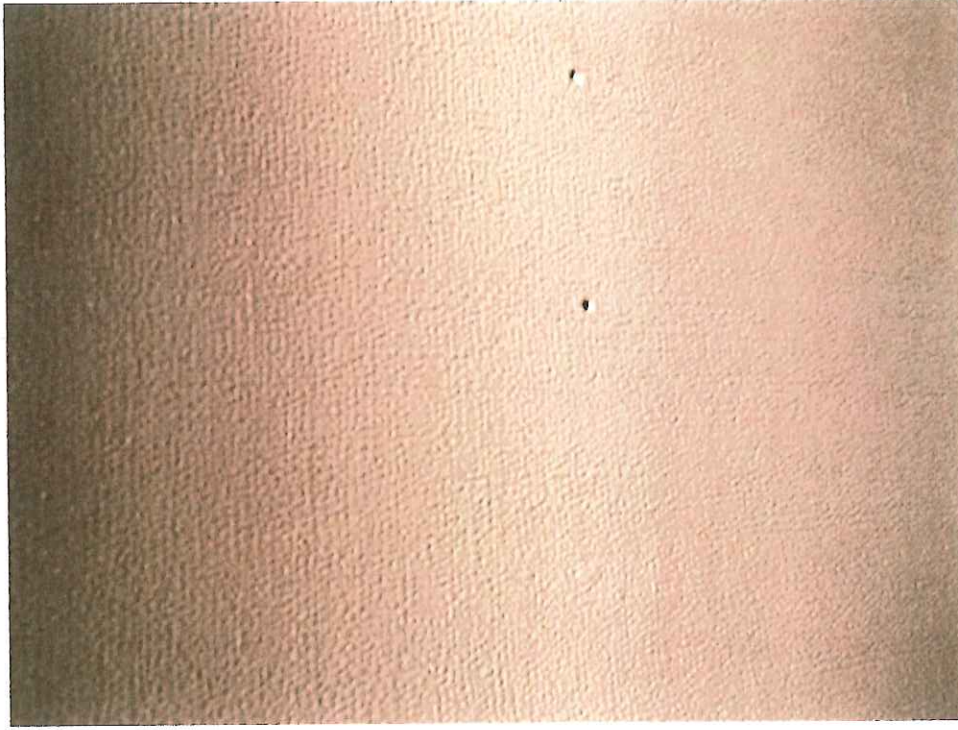
3. Closeup of Lead-Based Paint Wallpaper Texture --  
Cafeteria Lunchroom
